South End Pool & Aquatic Equipment/ Systems Improvement Analysis and Recommendations

Troy, NY

May 19, 2017

CHA Project No: 32892

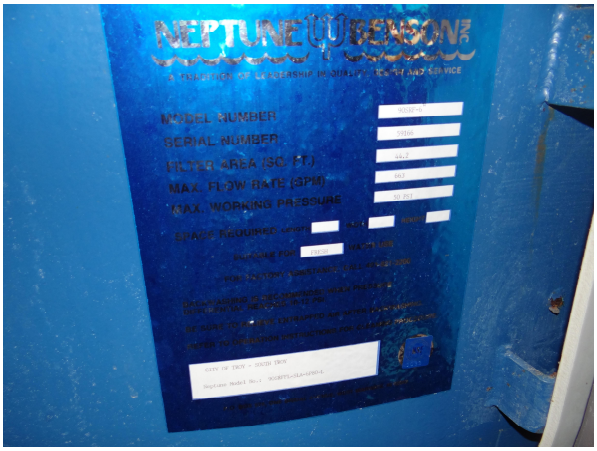
The existing *filtration system* is a single tank steel vertical high rate sand filter manufactured by Neptune Benson which is showing significant signs of corrosion. It has reached the end of its useful life and should be replaced. High Rate Sand is one of the more common methods of swimming pool filtration and is a reliable and low maintenance option. Although the nameplate is difficult to read with rust staining present, we believe the filter is original to the pool's construction which would place it at or around 40 years old. Fiberglass filtration systems have been around for a number of years and have proven to be both resist to the demands of corrosion while still maintaining the structural integrity of the pressure (and vacuum) conditions experienced. We would therefore recommend that a fiberglass High Rate Sand filtration system with automatic controls be installed.

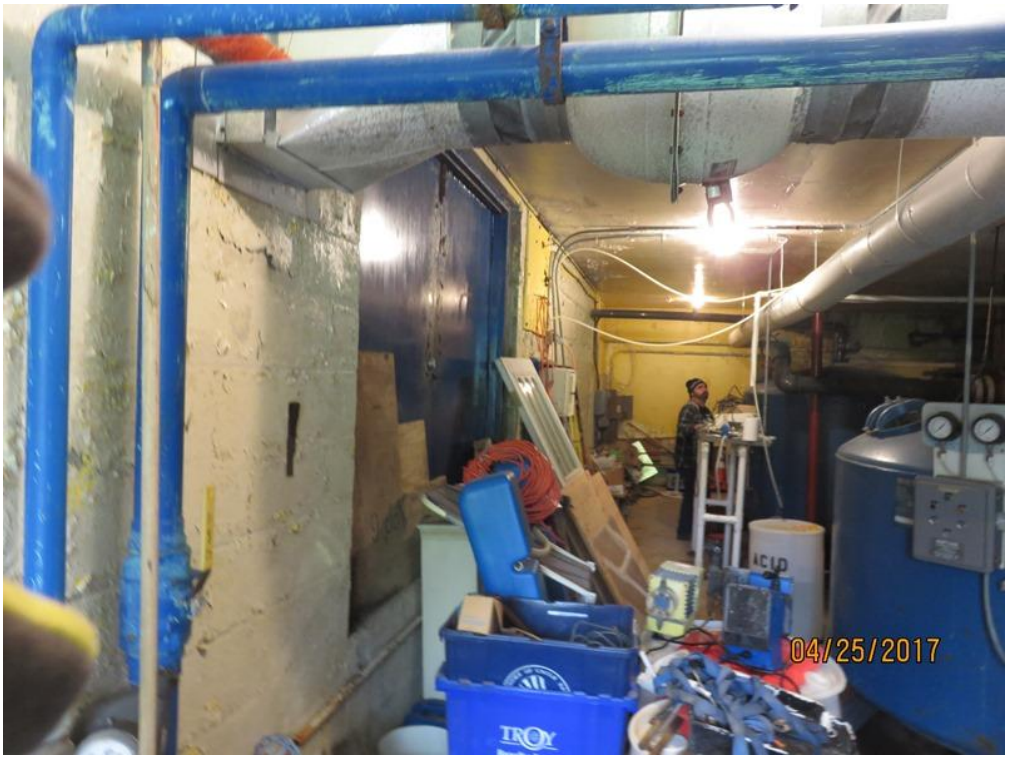
PHOTO No: 3	
LOCATION: Entrance to filter room	
DESCRIPTION: General view of the mechanical / plumbing building.	
PHOTO No: 4	
LOCATION: Filter Room

DESCRIPTION: General view of interior of Filter room

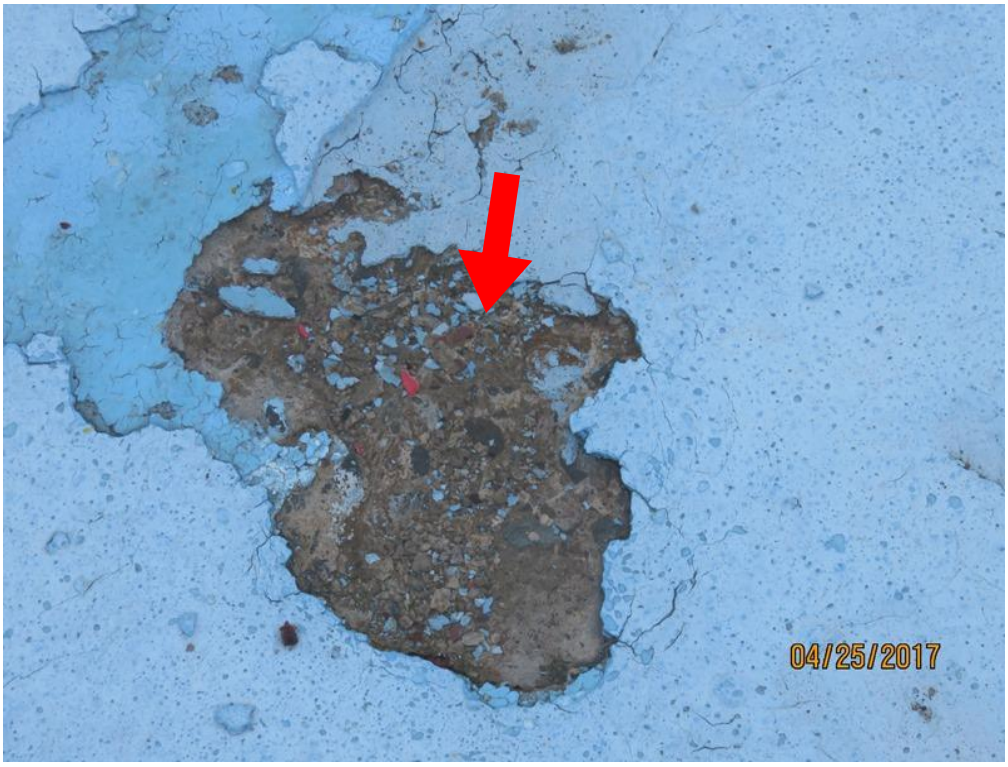
e) At several locations, we observed areas of deteriorated epoxy coating (waterproofing) on the pool floor and walls (*See Appendix B, Photograph Nos: 10 and 11*).

PHOTO No: 9	
LOCATION: Exterior of Concrete wall - Filter room	
DESCRIPTION: Deteriorated rubber seal at pipe penetration through concrete wall. Water leaking through joint.	
PHOTO No: 10	
LOCATION: Swimming pool concrete floor (Slab-on-grade)

DESCRIPTION: Deteriorated plaster and vinyl waterproof on concrete floor.

6. The interior of all pool walls and floor should be epoxy painted or waterproofed.
7. All pipe penetrations through the pool walls should be replaced.

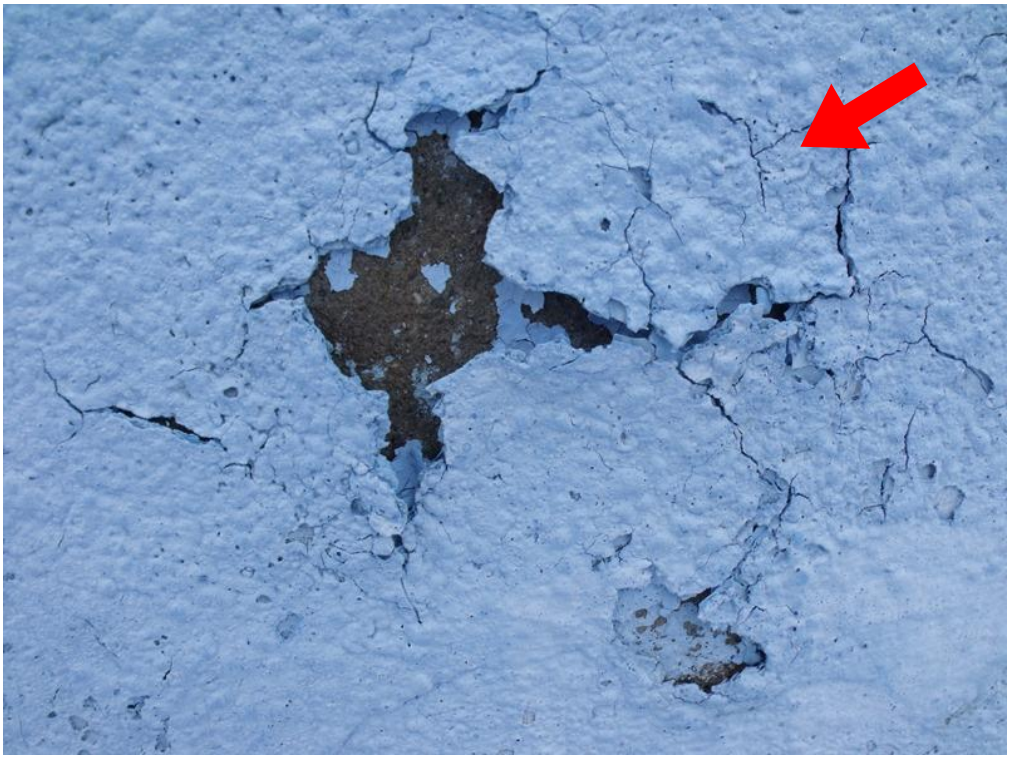
PHOTO No:11	
LOCATION: Pool Site – Pool Floor

DESCRIPTION: Deteriorated plaster and vinyl waterproof on concrete wall.	
PHOTO No: 12	
LOCATION: Pool Site – Pool Wall.	
DESCRIPTION: Delaminated concrete and large concrete spall on wall.
